WINDING CYPRESS CDD

7180 Winding Cypress Drive
Naples, FL 34114

Assessment Overview

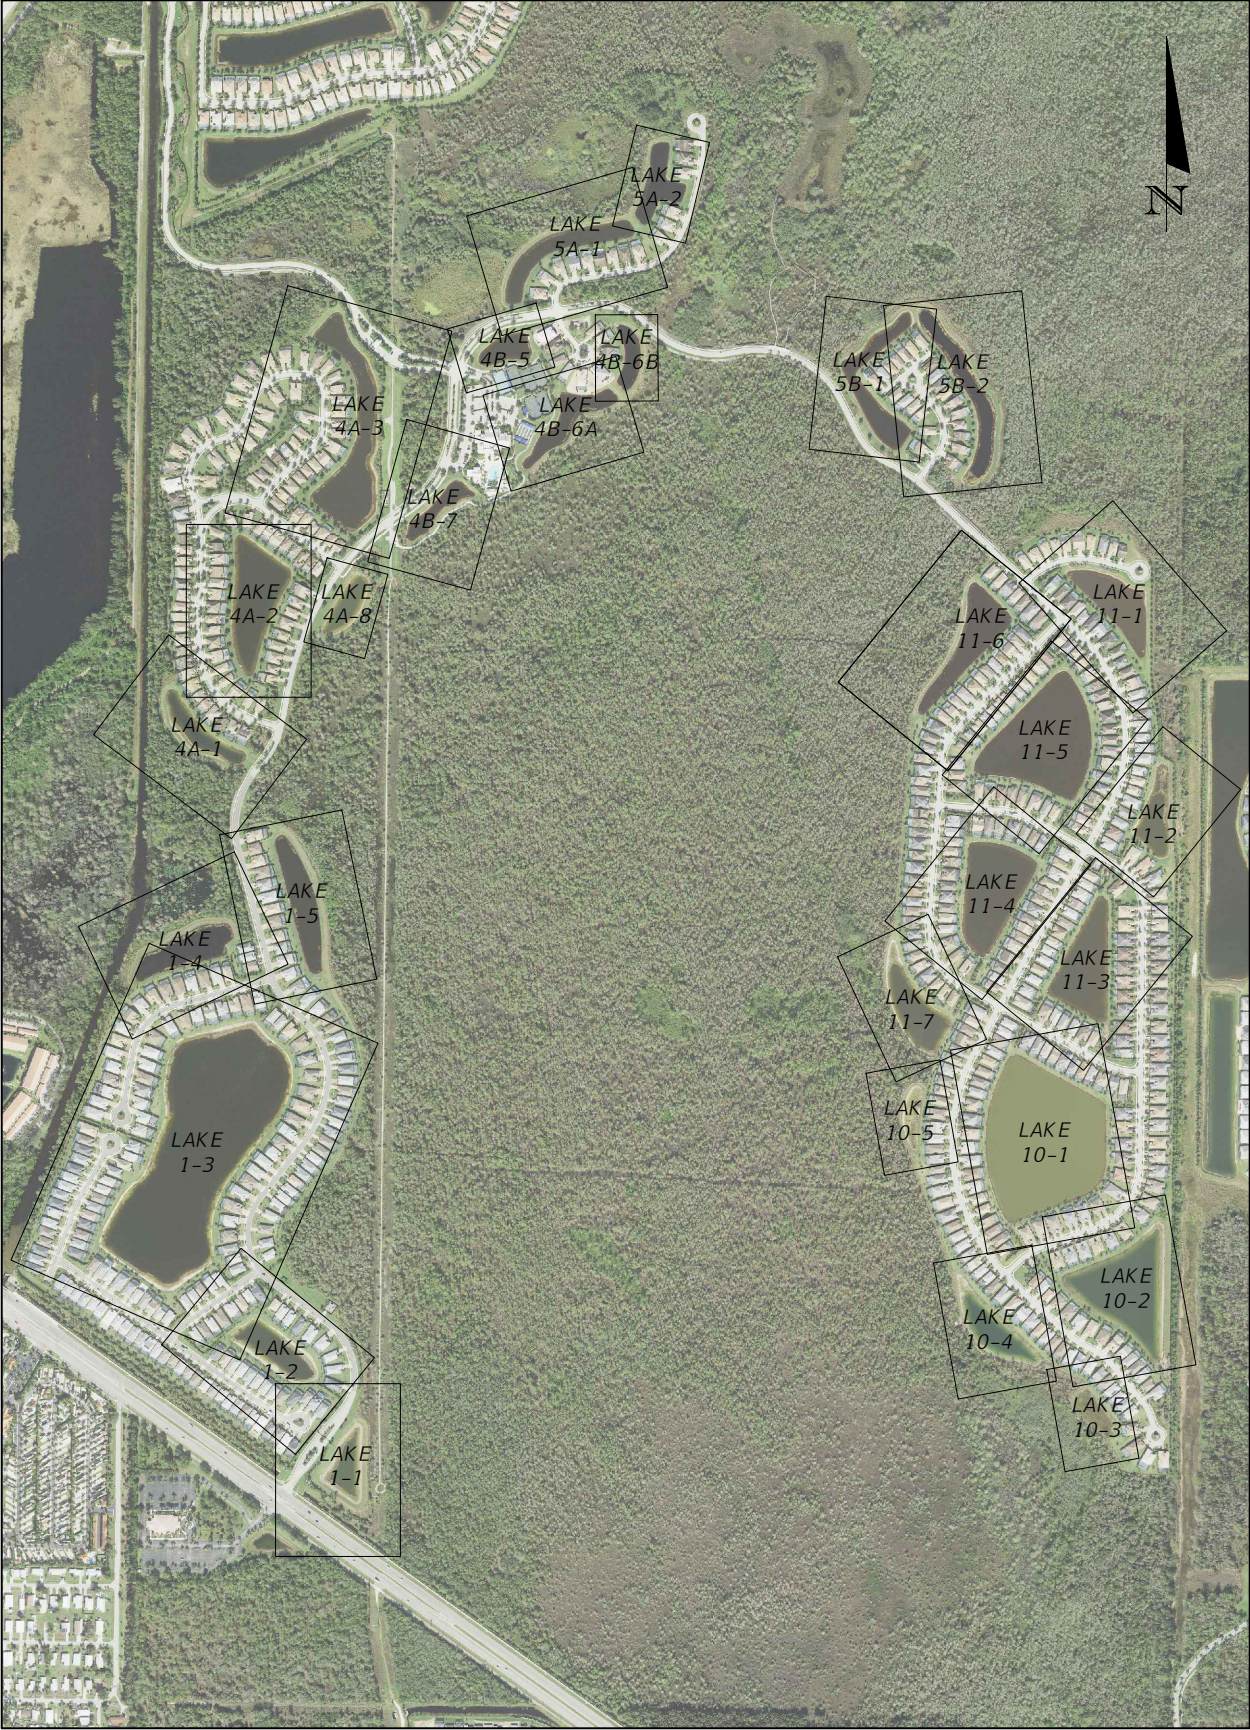
Lake 1-1 is located at the entrance at US-41. A total of 15 data points were collected with 5 problems identified. It is atypical of most of the lakes since there are no homes located adjacent to the lake. There are not too many erosion issues associated with this lake. The offsite erosion is caused by the sharp points of the lake shape. Two exotic plants are found on the lake banks and should be removed. Minor erosion was observed at a pipe connection.

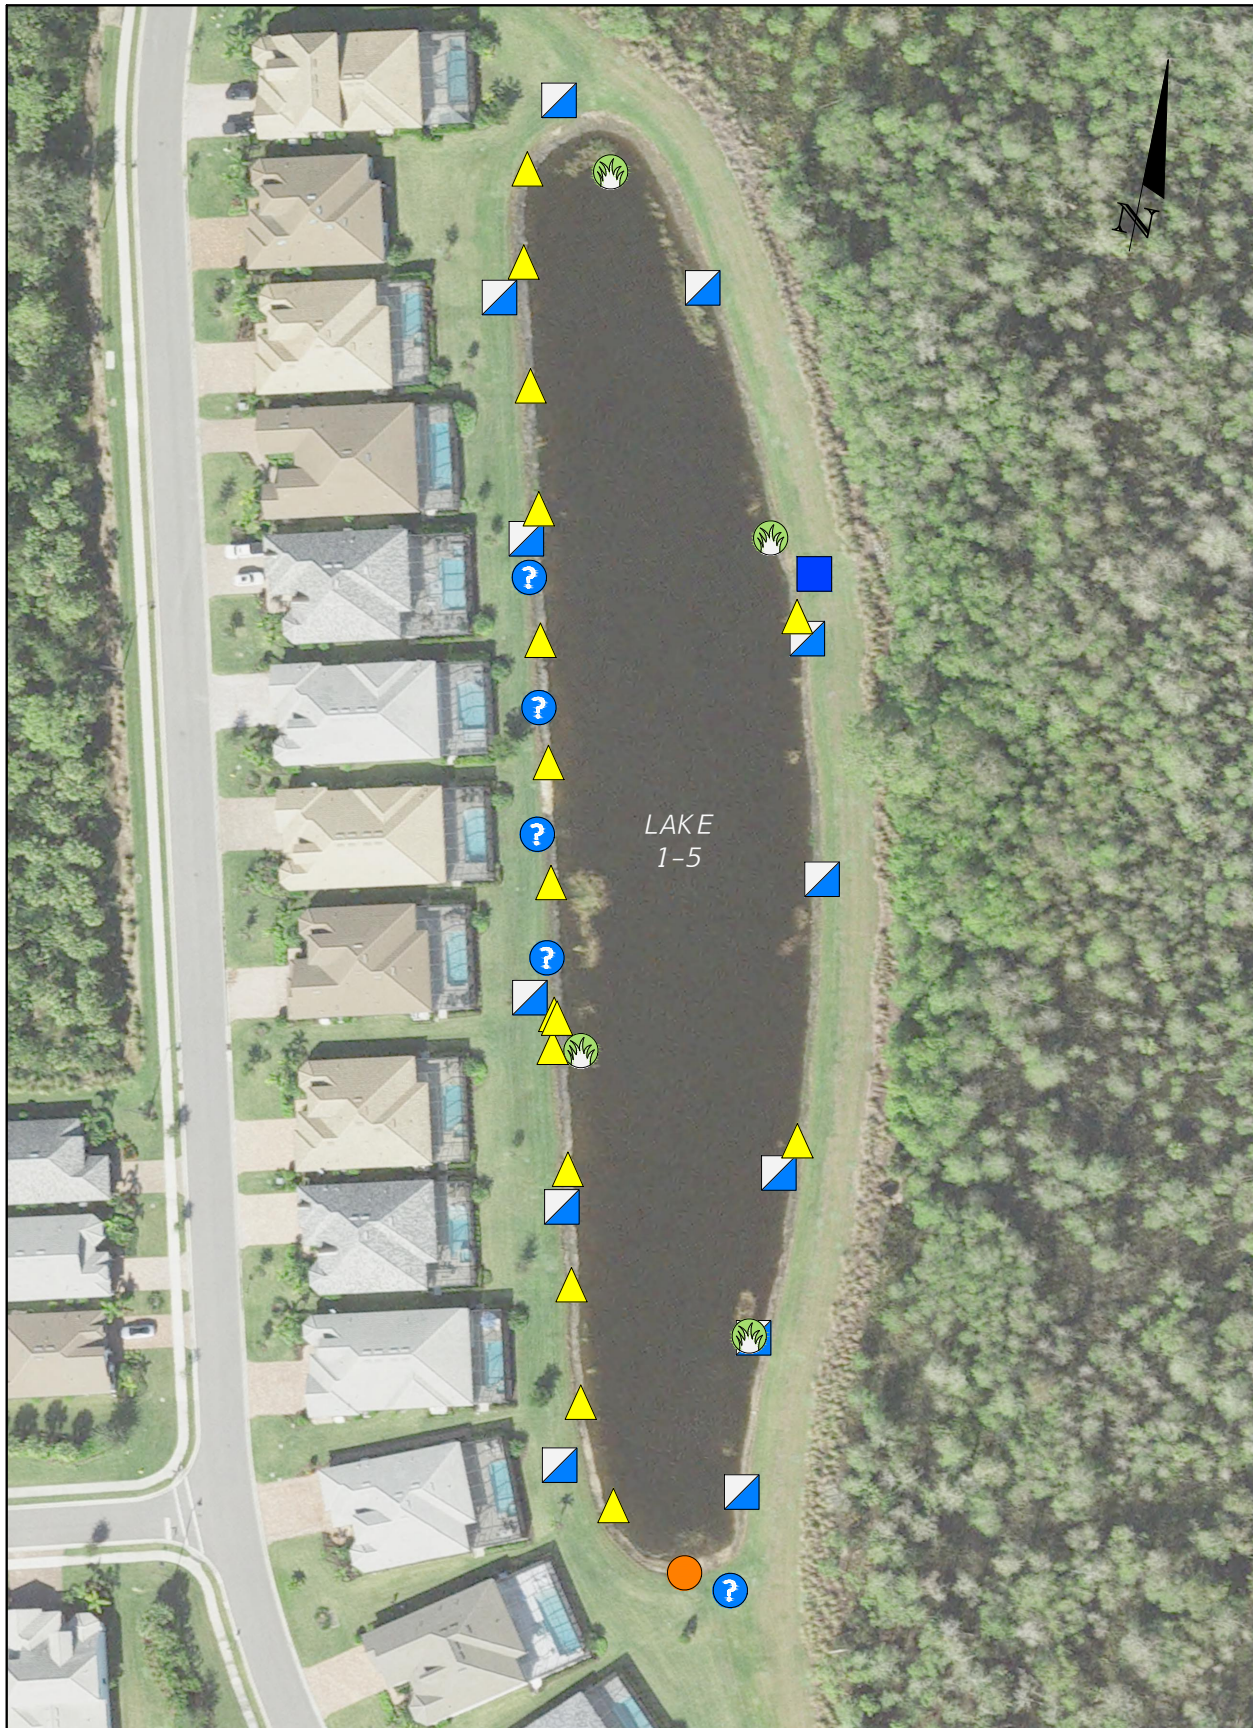
Lake 4A-1 is encumbered by homes on one side. A total of 24 data points were collected with eight issues observed. Half of the instances of erosion were caused off-site erosion. Three of those instances were from home-sites and the fourth from the grades at the corner of the lake. Drop-offs were noted in two located.

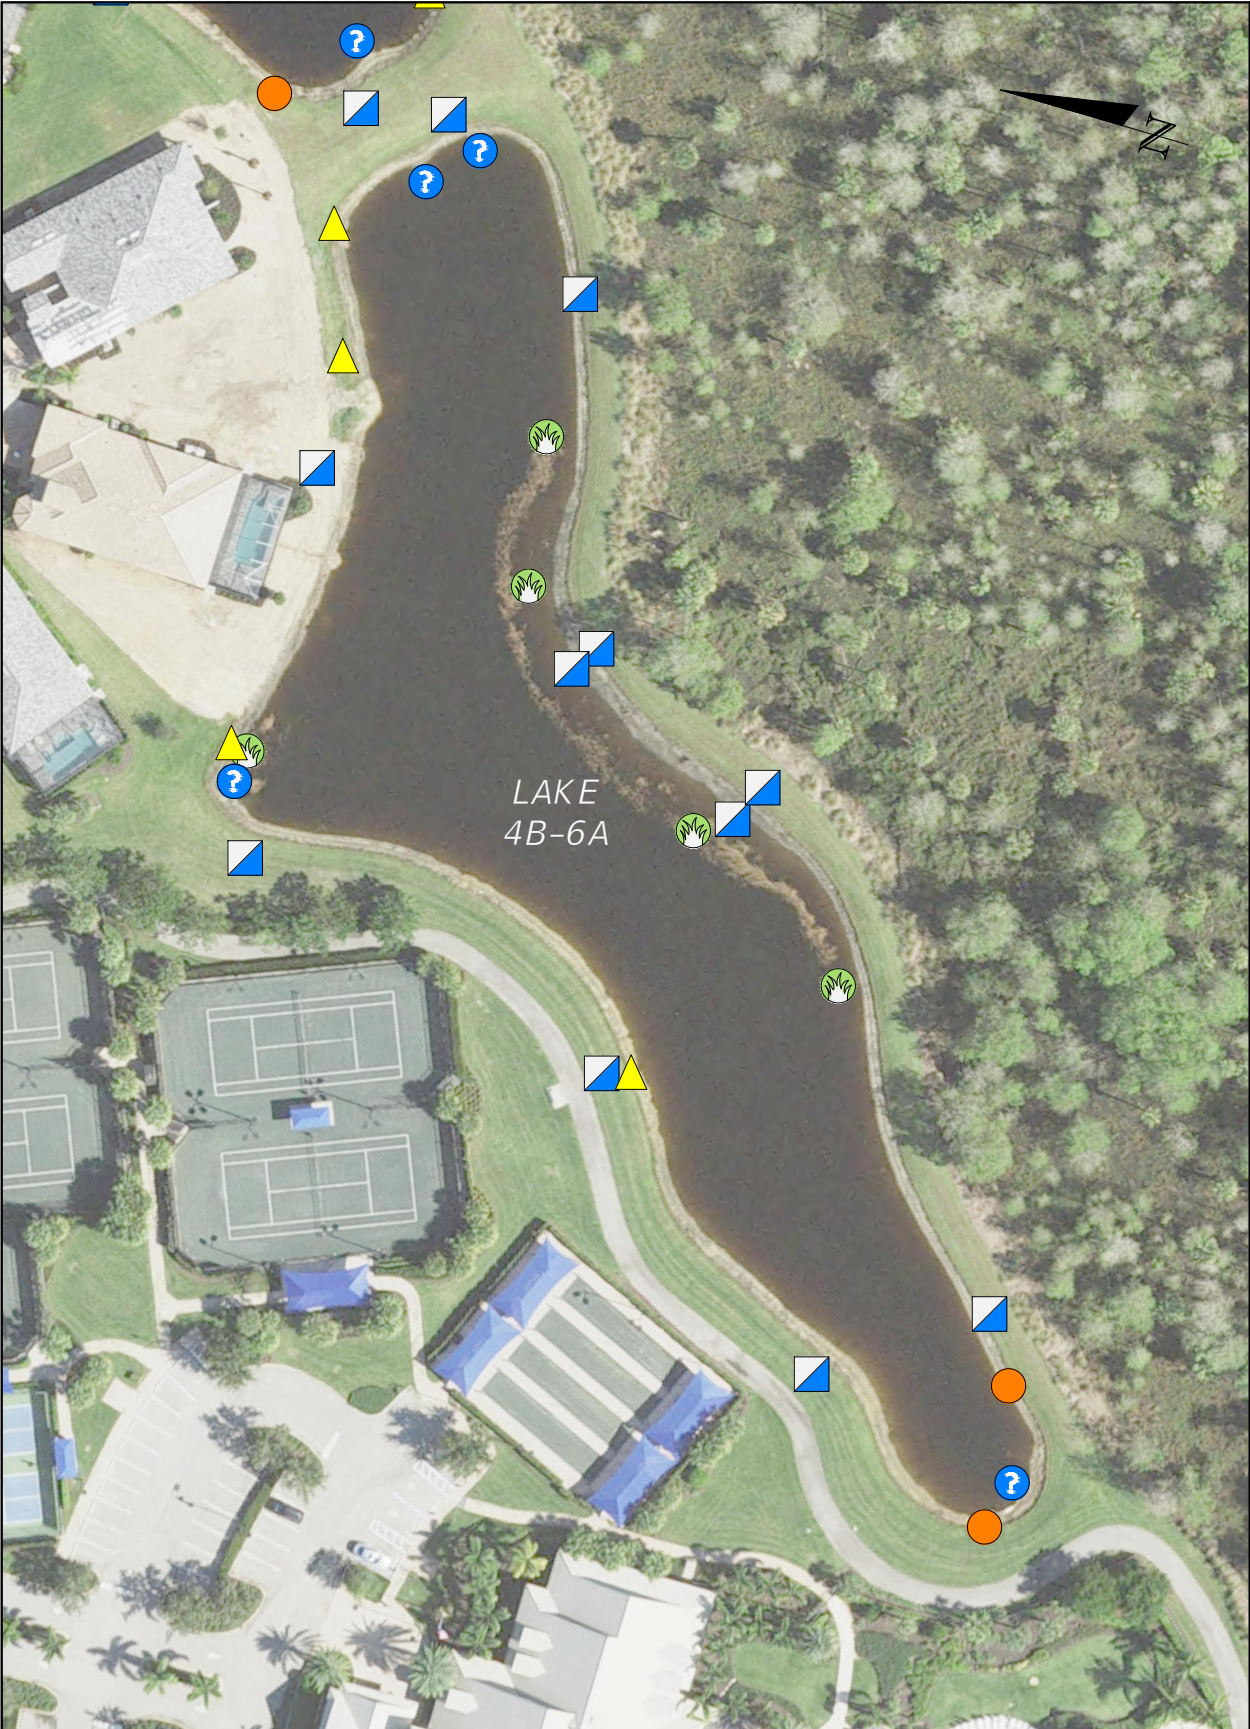
Lake 4B-6B is located just north of Lake 4B-6A. A total of 22 data points were collected with 9 problems identified. Four areas of erosion were noted. Two caused by downspouts from the adjacent home and two from grading around the corner of the lake. Rip-rap was present in the northeast corner, presumably to address an erosion issue. However, it appears the area has continued to erode and expose the fabric under the riprap and caused displacement of the rip-rap.

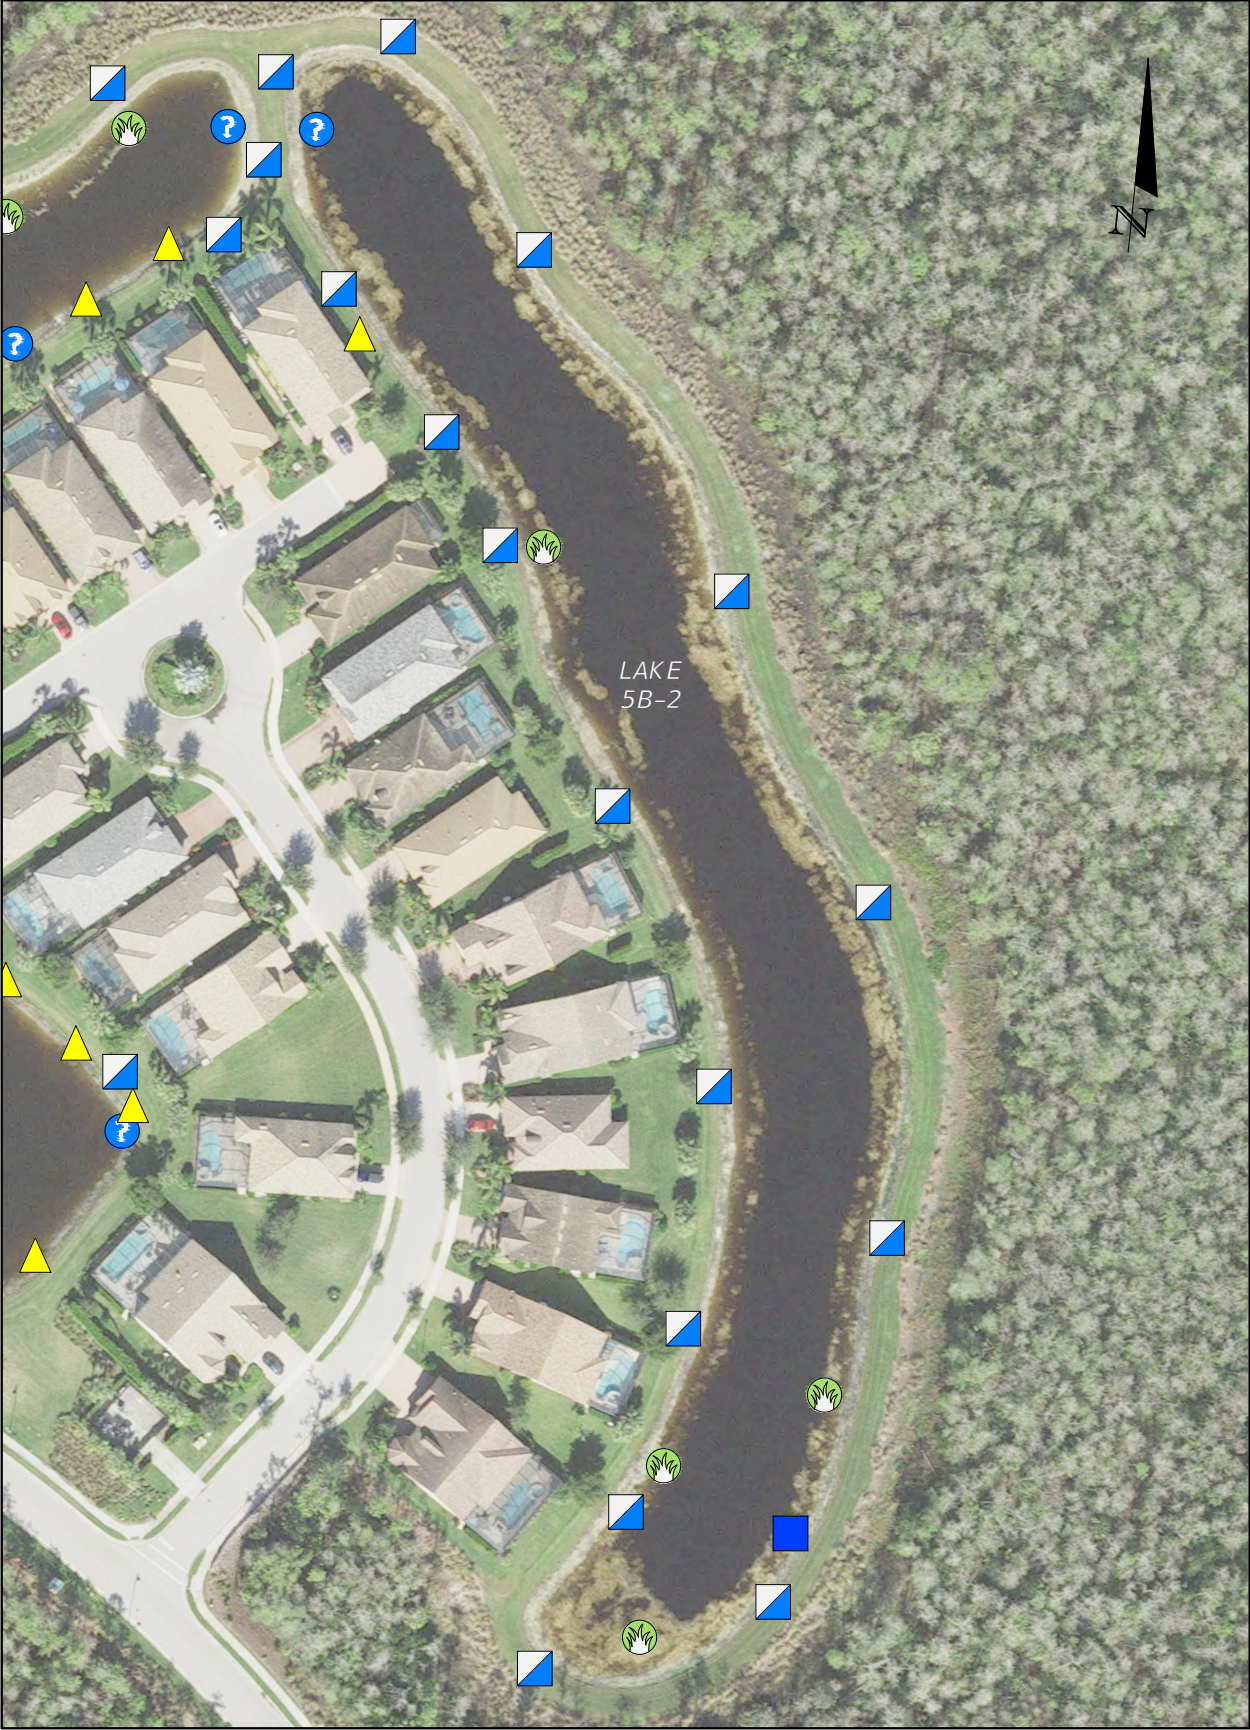
Lake 10-1 is one of the largest lakes on-site and is surrounded by homes. A total of 73 data points were collected with 58 issues identified. There were 36 points of erosion cause by home-site drainage. This lake had the most cases of drop-off with 22 occurrences.

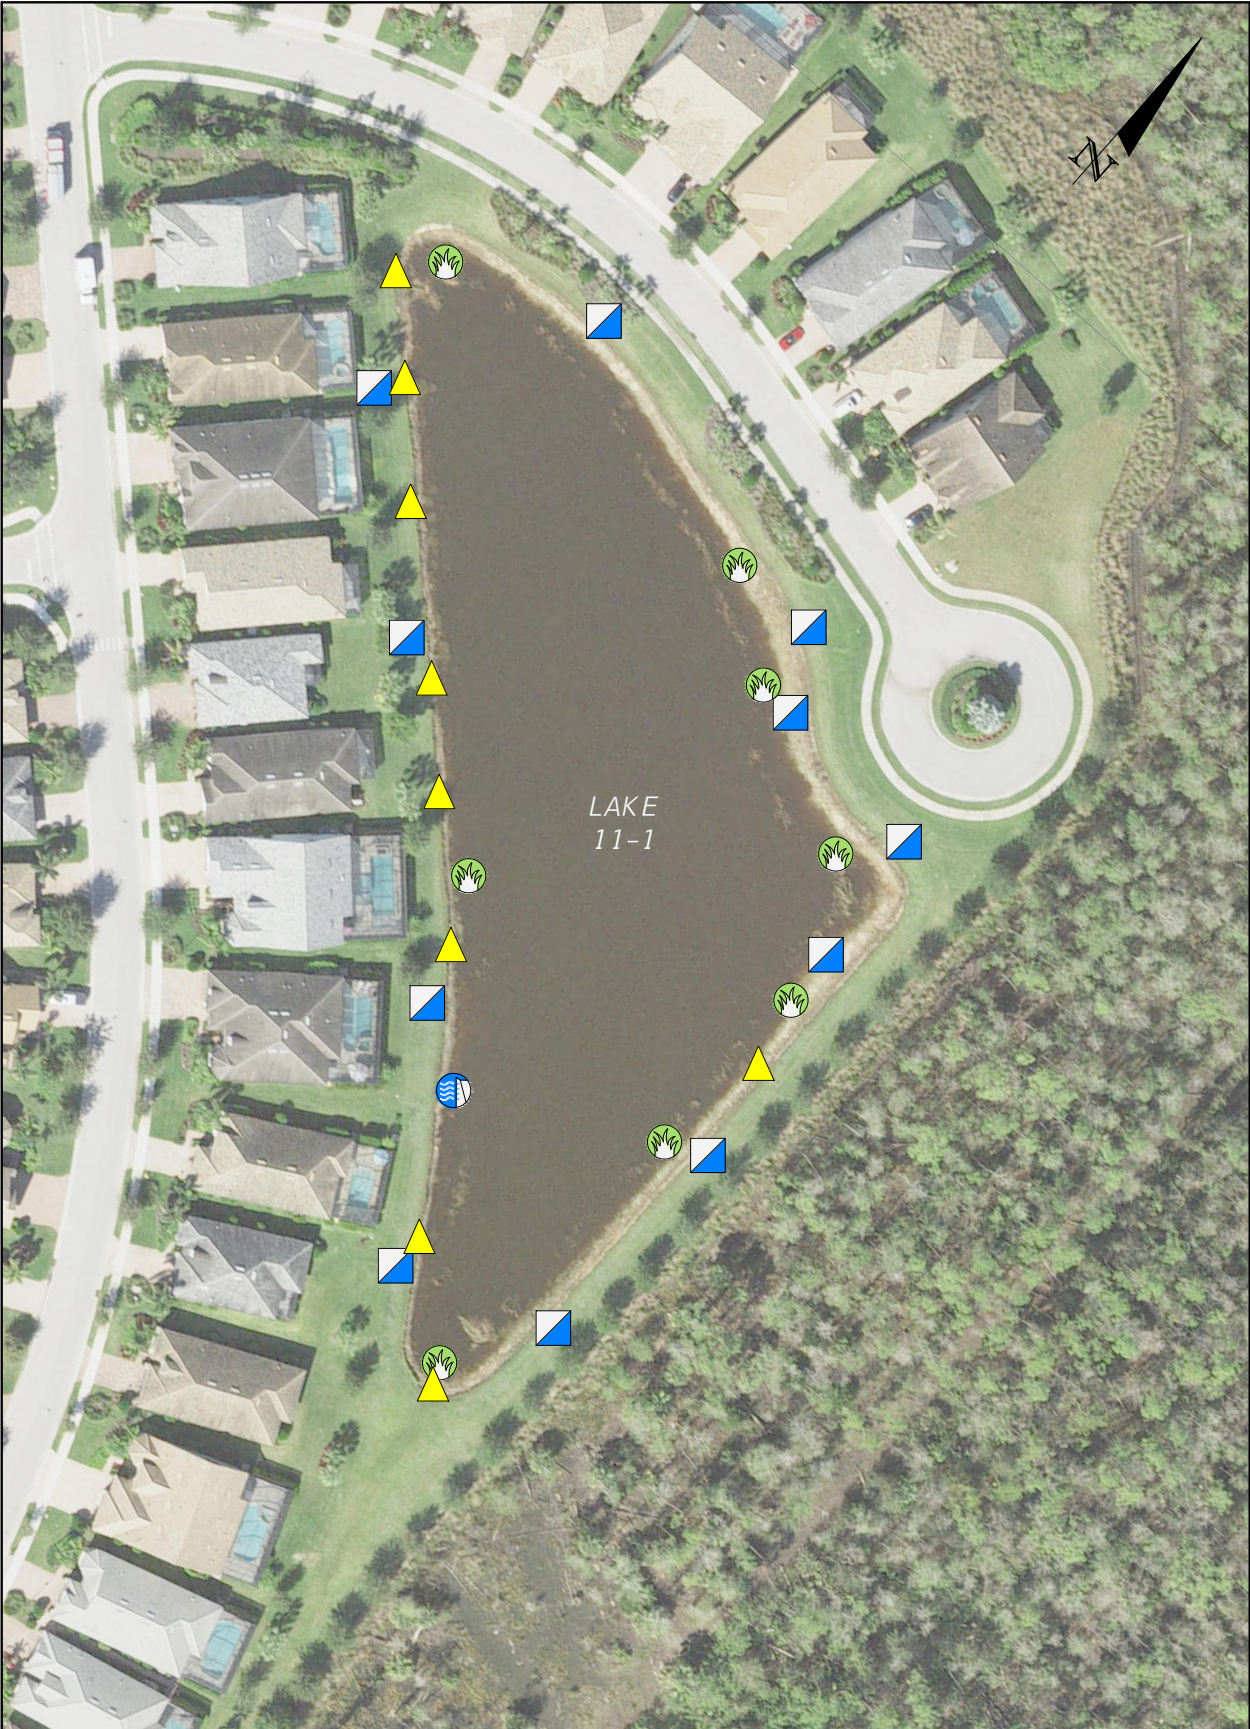
Lake 11-2 is located south of Lake 11-1. A total of 24 data points were collected with 9 problems identified. All of the erosion was caused by off-site drainage. 8 instances were from rooftop drainage, and one was from a swale on the north side of the lake.
