WINDING CYPRESS CDD

7180 Winding Cypress Drive
Naples, FL 34114

Assessment Overview

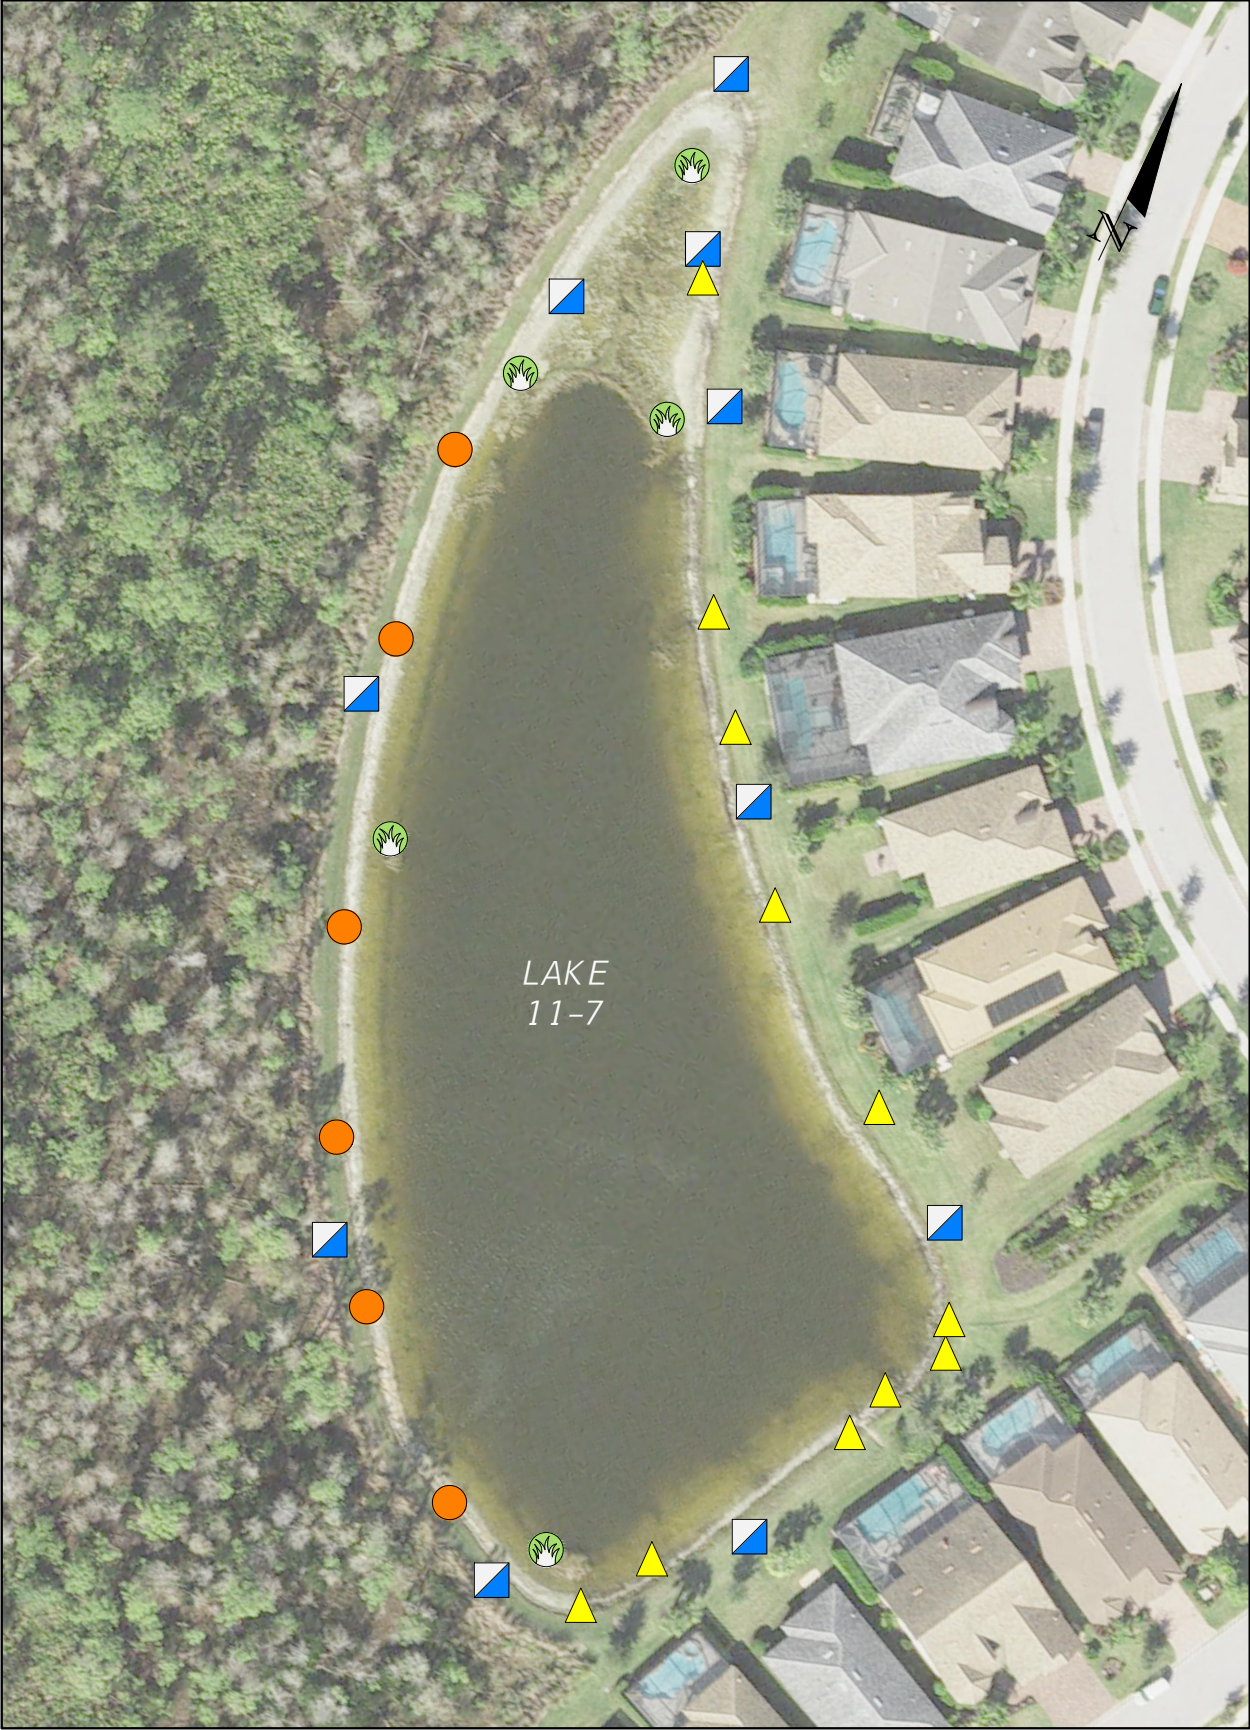
Lake 11-7 is located at the southern corner of Winding Cypress Drive and Blackberry Drive. A total of 32 data points were collected with 17 identified as problems. There were 11 erosion issues caused by off-site drainage, with 8 instances caused from downspouts, two from a pool overflow pipes, and one from a swale in the northeast corner. Escarpment was observed in 6 locations, all of which were located on the natural side of the lake.
